Aber Home Inspections, Inc
9801 Goodrum Ct
Raleigh, NC 27617
919-845-2500
919-272-4428

Inspected By:
Robert E Aber - NC Lic. No. 854

Record Number 1

Inspected 1/1/09 10:00 PM

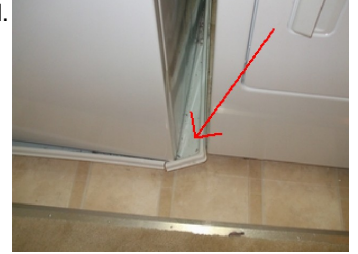
Laundry - The plastic drip/overflow pan under the washing machine is cracked and should be replaced.
Contact a qualified contractor for evaluation and correction

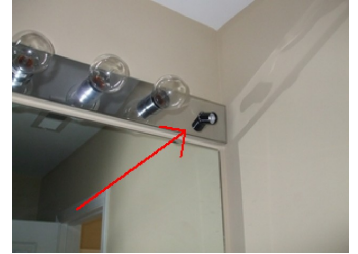
Master bath wall fixture - Right lampholder is loose/broken and no bulb is installed
Contact a qualified licensed electrician for evaluation and correction
