ABER HOME INSPECTIONS, INC.
Raleigh, North Carolina
919-845-2500
www.aberhi.com
bob@aberhi.com

Doe, John
32 Elm Street
Anytown, NC
Record Number

Inspected 8/20/18 9:30 AM

Inspection Summary

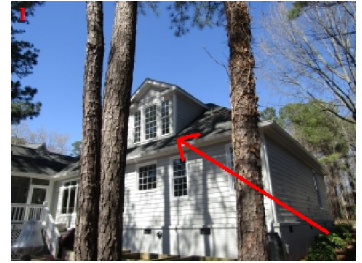
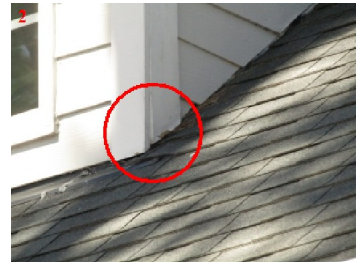
1.05 Trim (1)

Rear - 2nd floor dormer - At the bottom of the right outside corner - Damaged/decayed trim should be repaired
Contact a qualified contractor for repair

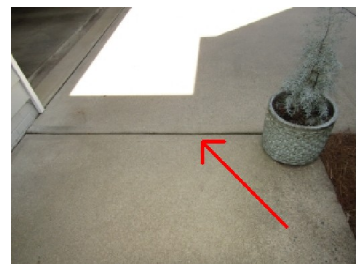
Front walk and driveway intersection - Exposed edges and irregular surfaces of heaved/sunken sections present trip hazards
Contact a qualified contractor for repair

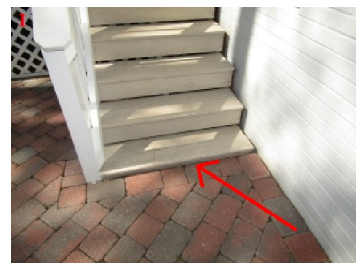
1.19 Steps

Rear patio brick to bottom step tread - The small difference in height presents a trip hazard
Contact a qualified contractor for repair

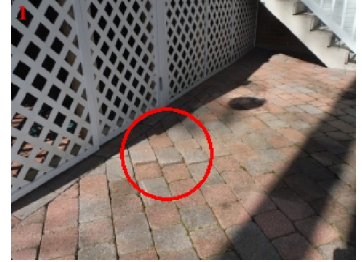
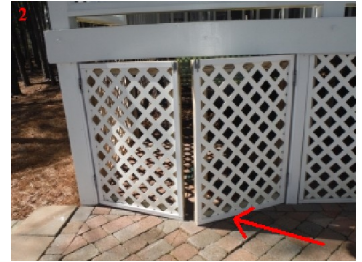
1.23 Patios

- A Outside the under-porch gates - SAFETY CONCERN - Heaved bricks present a trip hazard [photo 1]
- B Also, the raised bricks prevent the right gate from opening [photo 2]
Contact a qualified contractor for repair

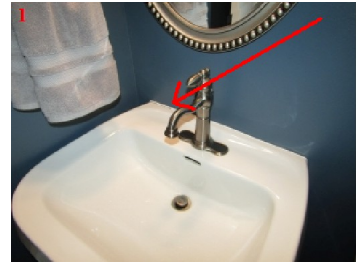
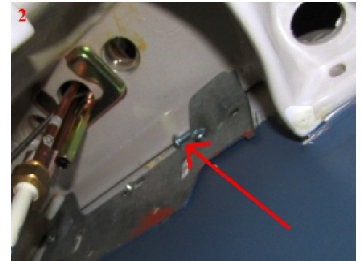
3.02 Fixtures

Half bath - The wall hung pedestal sink is loose. This may explain the loose caulk at the back left edge [photo 1] and the presence of at least one loose screws that has, apparently, been used as a "shim" on the wall bracket under the sink [photos 2 and 3]. Contact a qualified licensed plumber or other qualified contractor for repair

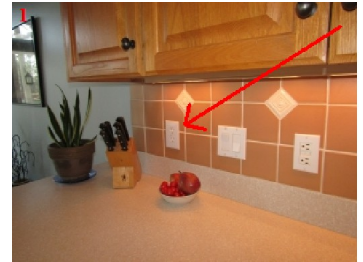
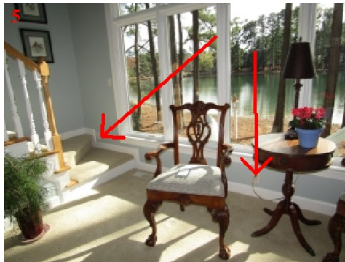
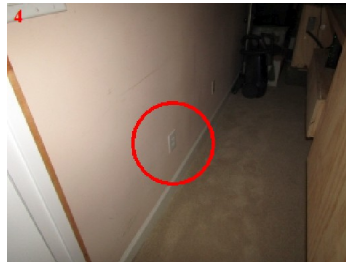
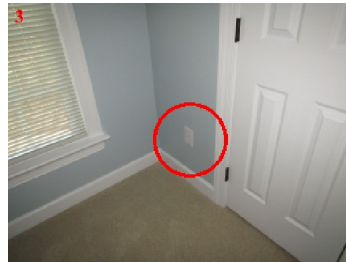
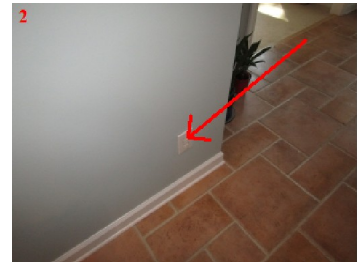
A Loose receptacles should be resecured in their wall boxes:

Miswired, broken or improperly installed receptacles can cause shocks or worse
Contact a qualified licensed electrician for repair

Contact the seller for clarification - especially if a wall switch is involved - or contact an electrician for repair

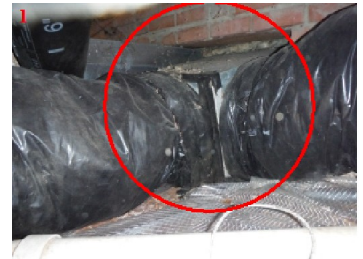
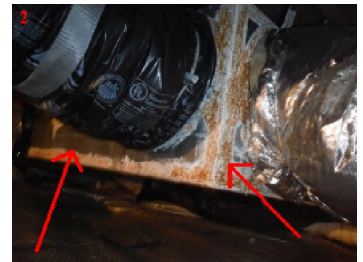
A The return duct for the gas pack metal ducting has sagged and is resting on the ground. It should be properly restored to its intended position to help prevent premature deterioration and to ensure appropriate air delivery

B The supply duct for the gas pack - Rust on the exterior of metal ductwork may be related to humid crawlspace air and/or poor or saturated insulation within the ductwork. The condition should be evaluated by a qualified licensed mechanical contractor with correction as needed to ensure that the negative effects of moisture in ductwork is not a concern and that the ductwork is not subject to premature failure, regardless of the cause.

Contact a qualified licensed mechanical contractor for repair as needed

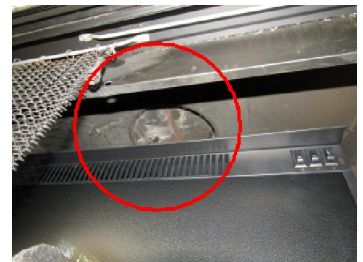
Staining at the top of the firebox, surrounding the flue opening, indicates moisture accumulation and intrusion in the form of rain or condensation. The source should be identified and corrected.

Contact a qualified fireplace expert for repair

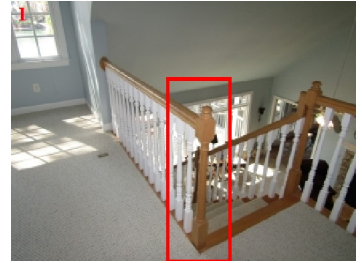
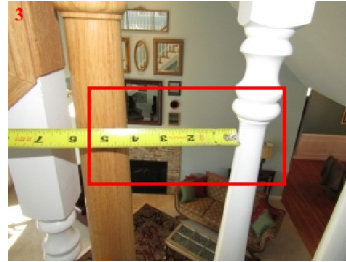
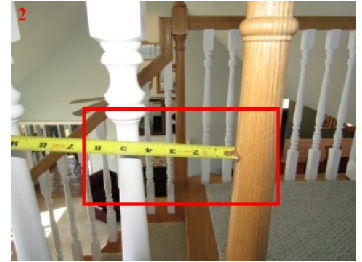
- A 2nd floor - The loose newel post should be resecured to ensure stability [photo 1]
 - B 2nd floor - Spacing between spindles and posts exceed 4-inches providing spaces for small children to fall through or get trapped
 - 1 At the loft railing newel post [photo 2]
 - 2 At the top landing post [photo 3]
- Contact a qualified contractor for repair

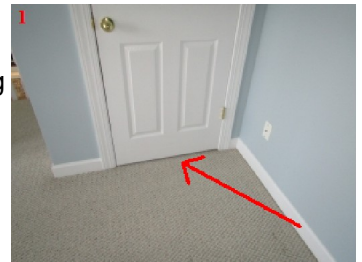
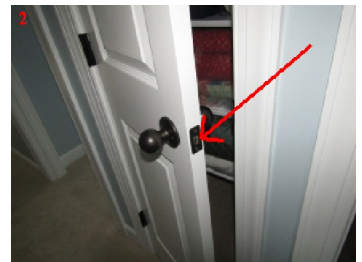
7.05 Doors and operating hardware

- A 2nd floor - Front walk-in attic - The missing bottom edge weatherstrip should be installed to help eliminate unwanted heat transfer and air infiltration [photo]. The door to the left rear walk-in attic is also missing a weatherstrip, however, conditioned air is being delivered to that attic. Adding a weatherstrip would not be productive in that case.
 - B Bedroom hall - Linen closet left of the hall bath - Door latch sticks and requires adjustment or repair [photo 2]
 - C Right front bedroom closet - Right door does not latch
 - D Under stairs closet - Door does not latch
- Properly installed and maintained doors should open, close, seal the opening and they should latch and lock, if designed to do so. They should not bind on trim components (or adjacent doors if doubles) or swing open/closed unless purposely moved.
- Contact a qualified contractor for repair

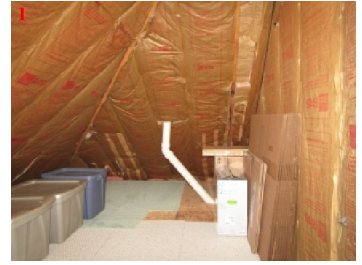
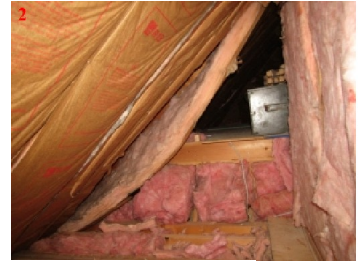
The sagging insulation in photo 2, which is in the left side eaves attic, can be repositioned when the insulation is covered.

Contact a qualified contractor for repair

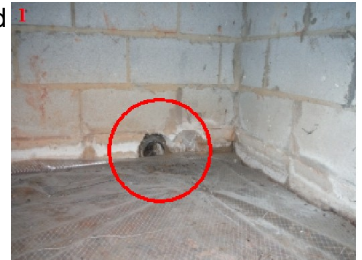
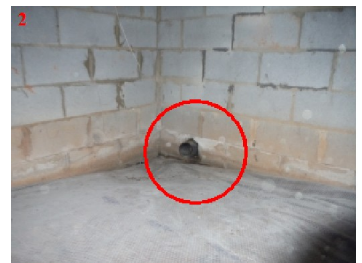
10.04 Drainage

ALSO, the exterior discharge ends of the drains were not found. They should be located and the drains verified as functional.

Contact a qualified contractor for repair

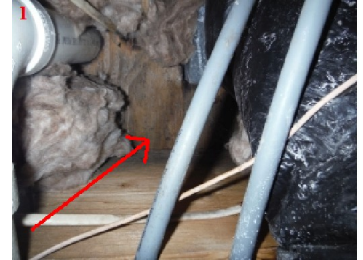
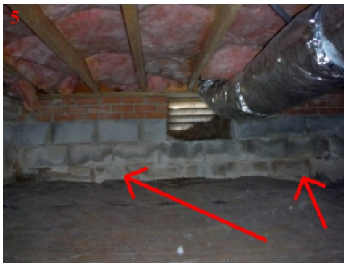
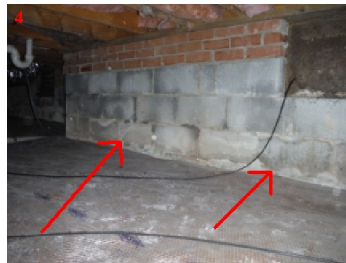
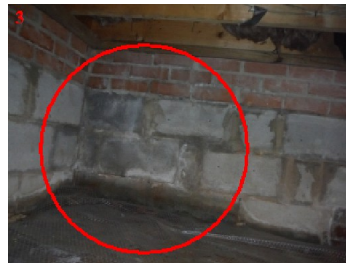
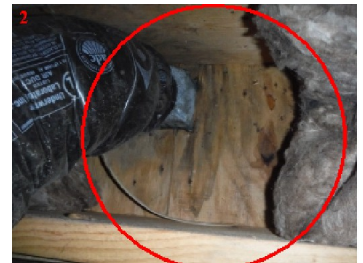
10.06 Evidence of excess moisture (1)

A Under the kitchen sink base cabinet - Subfloor discoloration may be a mildew-like substance that resulted from condensation caused by cool conditioned air mixing with warm and humid crawlspace air during the cooling season. This may indicate that there are air leaks between the flex duct and the metal through-floor fitting.

B The same condition exists under the dining room vent [photo 2]
All such air fittings should be fully evaluated and properly sealed and insulated
Contact a qualified contractor for correction

C Front - At the left front inside corner under the dining room - Water marks on the cement block indicate moisture penetration from the exterior [photo 3]. This is opposite the entry steps where a potted plant is located. The moisture penetration may be the result of overspill from watering the plant.

D *Efflorescence on front walls indicates moisture migration through the walls from the exterior [photos 4 and 5]. This can be the result of wind-driven rain, overflowing gutters, misdirected downspouts, exterior grading that directs ground water or roof runoff toward the foundation, misdirected lawn sprinklers or even a leaking garden hose. Efflorescence is not harmful, but is an indication of moisture movement that should be monitored for change with correction as needed.

Contact the seller for clarification or a qualified contractor for further evaluation with repair as needed

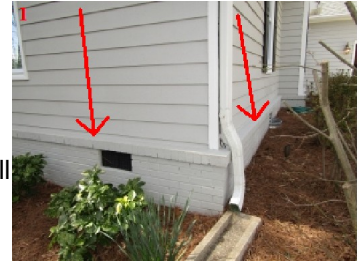
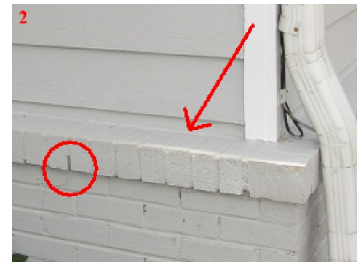
1.04 Flashings

General - At the water table atop the foundation brick veneer - There is no visible flashing between the siding and the brick. The joint between the two materials has been caulked. Caulk is not a substitute for properly installed flashing. However, there is no readily apparent damage that might relate to moisture intrusion. It may be that conscientious caulking of this joint as served well. Suggest monitoring the condition of the siding as well as the interior perimeter of the wall substrate (as seen from inside the crawlspace) with correction as needed

It should also be noted that weep holes are installed at joints in the water table brick [photo 2 circle]. This would indicate the probability of flashing installation behind the brick, but that flashing would not, necessarily, translate to appropriate flashing of the siding/brick intersection

Contact a qualified licensed general contractor for further information regarding normal building practice as pertains to joint treatment at the intersection of fiber cement or hardboard siding with brick.

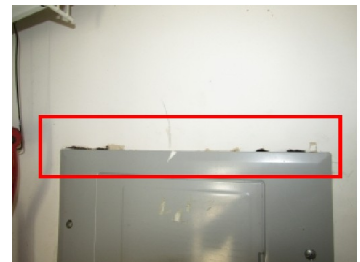
1.10 Garage

Above the electrical panel - Holes/gaps in drywall common to living spaces or attics common to living spaces MAY be considered a violation the integrity of the fire separation wall

Contact a qualified contractor for further evaluation with repair as/if needed

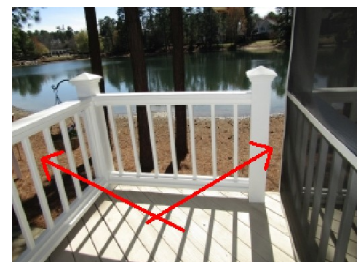
1.21 Railings

Spaces greater than 4 inches between spindles provide a safety hazard for children because they can fall through or get caught in the openings

Contact the local building authority and/or a qualified contractor for further information

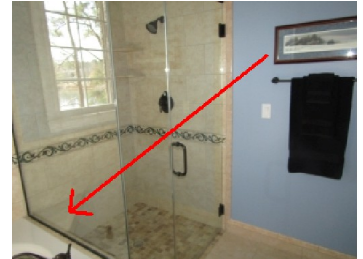
Master bath shower - The strength and integrity of the corner seat cannot be verified during a home inspection

You may wish to have the seat evaluated by a qualified contractor

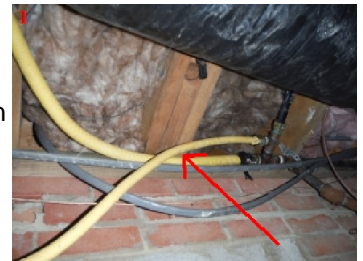
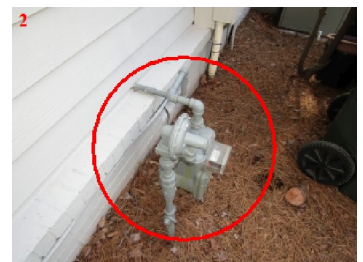
The gas piping in this house includes corrugated stainless steel tubing (CSST). Photo 1 is an example of such piping in the crawlspace. There is no readily visible electrical bonding connection between the gas piping system and the electrical system, other than connections at the gas appliances that utilize the grounding conductors for the appliances. The bond is usually found at the point where the exterior gas line passes through the wall, on the right side of the house, as shown in photo 2. The lack of strong electrical bonding may increase the potential for lightning strikes to cause arcing at the CSST gas piping that may result in perforation of the piping, gas leaks, and fires.

For safety, it is recommended that this installation be further investigated by a licensed electrical contractor and corrected as needed

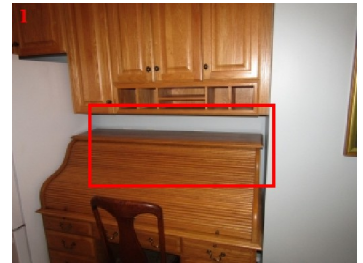
4.15 Receptacles

Kitchen - Left wall - One or more receptacles behind the roll top desk could not be checked.

Verify safe functionality
